Shear strengthening of wall panels through jacketing with cement mortar reinforced by GFRP grids

Marco Corradi ^{a,*}, Antonio Borri ^b, Giulio Castori ^b, Romina Sisti ^b

This paper gives the results of a series of shear tests carried out on historic wall panels reinforced with an innovative technique by means of jacketing with GFRP (*Glass Fiber Reinforced Plastics*) mesh inserted into an inorganic matrix. Tests were carried out in situ on panels cut from three different historic buildings in Italy: two in double-leaf rough hewn rubble stone masonry in Umbria and L'Aquila and another with solid brick masonry in Emilia. Two widely-known test methods: the diagonal compression test and the shear-compression test with existing confinement stress. The test results enabled the determination of the shear strength of the masonry before and after the application of the reinforcement. The panels strengthened with the GFRP exhibited a significant improvement in lateral load-carrying capacity of up to 1060% when compared to the control panels. A numerical study assessed the global behavior and the stress evolution in the unreinforced and strengthened panels using a finite element code.

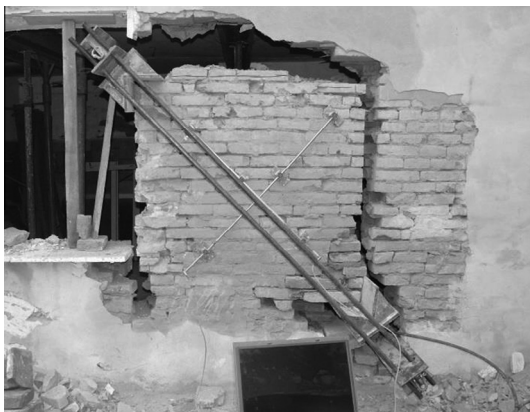
Fig. 1. On-site diagonal compression test (San Felice building).

In the diagonal compression tests, 1200 × 1200 mm panels were isolated from the surrounding walls by making four cuts with a circular saw. In cases where it was possible to obtain samples underneath existing openings, it was possible to reduce the number of cuts made to three (Fig. 1). The shear strength of the masonry at the center of the panel (τ_{0D}) was calculated on the basis of the interpretation of the test reported in the RILEM standards [22]:

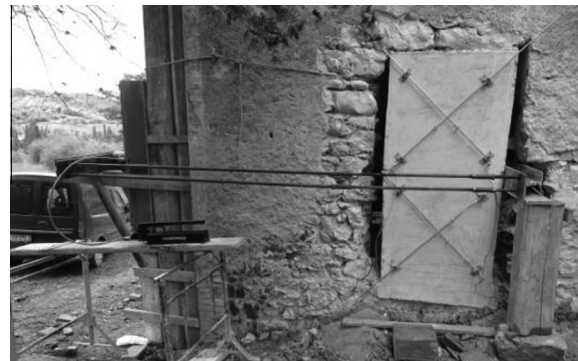
Fig. 2. On-site shear-compression test (Colle Umberto building).

For the shear-compression test, the panel, 1800 × 900 mm in size, was obtained by two vertical cuts in the masonry (Fig. 2), i.e. letting the vertical compression load from the remaining part of the building act on the top of the sample. The horizontal force is applied to the midpoint, and in this way the panel can thus be schematized as two superimposed 900 × 900 mm semi-panels. The vertical stress is estimated based on the analysis of the loads weighing on each sample:

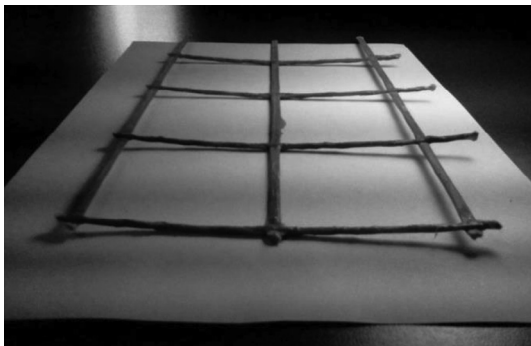
Fig. 3. Detail of the GFRP grid.

The GFRP grid used is manufactured by Fibre Net S.r.l. and is characterized by square mesh with nominal dimensions of 66×66 mm. It is made up of AR (*Alkali Resistant*) glass fiber with a zirconium content equal to or greater than 16% pre-impregnated with thermosetting epoxy vinyl ester resin (Fig. 3). The geometric and mechanical properties, measured with tensile tests are shown in Table 1.

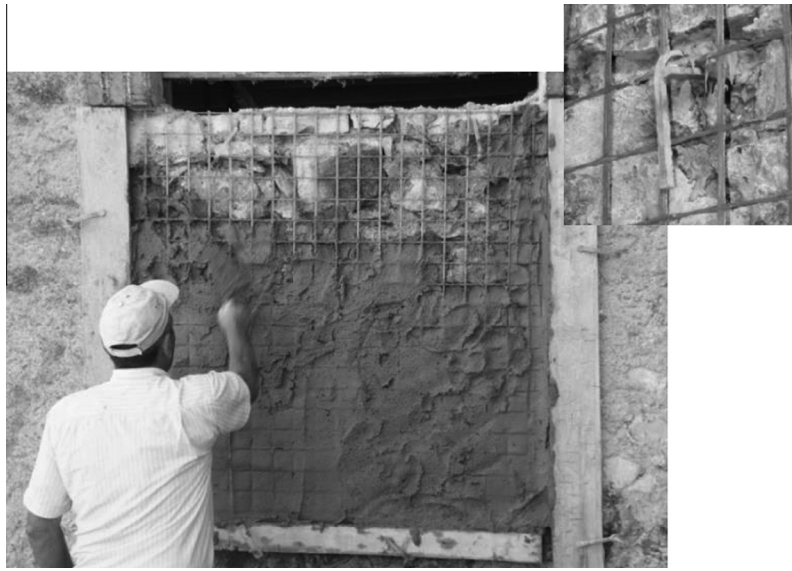
Fig. 5. Application of mortar jacketing and detail of connection between anchors and GFRP grid.

Lastly mortar was applied by hand in a thickness of about 30 mm. Despite the presence of the composite grid, the application of mortar was not difficult, thanks to the large mesh size adopted (Fig. 5).

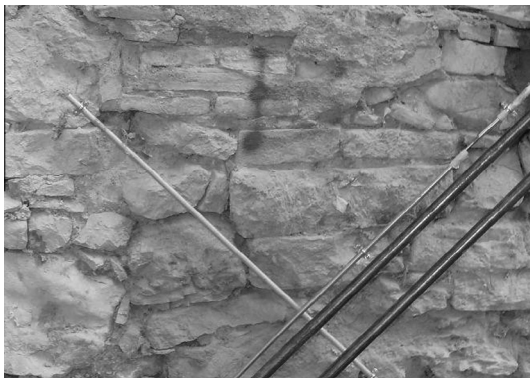
Fig. 6. Stonework of Colle Umberto farm house (19th-century).

The building is characterized on the ground floor by two types of walls built in different periods. The first type, which presumably goes back to the early 1800s, is 560–570 mm thick and was made with very poor lime-based mortar. The stones are up to 350 mm in

size, and are well squared (Fig. 6). The second type, built in the early 1900s, is 480 mm thick and has lime-based mortar with better mechanical properties (Fig. 7). However, the stones are very rough hewn and almost square in shape, with sides of not more than 250 mm. In both wall types there are no through stones.

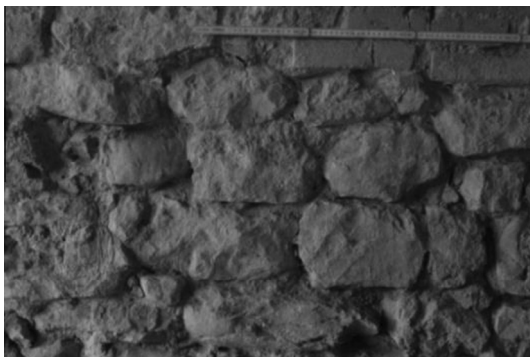
Fig. 7. Stonework of Colle Umberto farm house (20th-century).

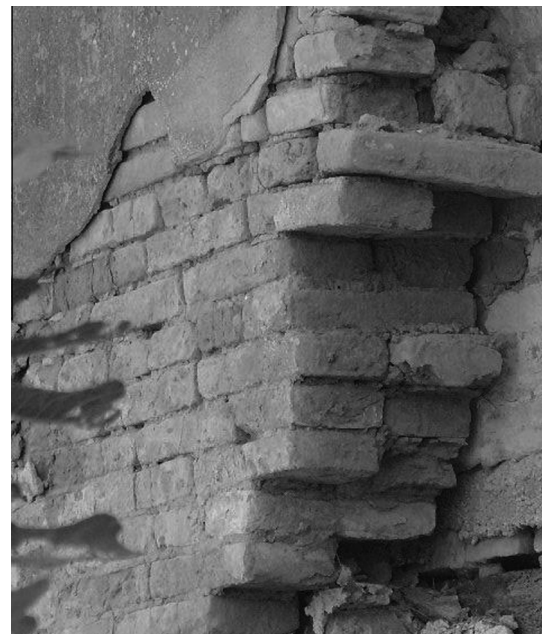
Fig. 8. Brickwork of San Felice building.

The building is rectangular in shape and completely isolated from other structures. It has three floors (ground floor, first floor and an attic) and is made entirely of solid brick masonry. The wall structure, however, is unusual in that the walls, which are about 300 mm thick, have few connecting bricks (headers) between the leaves (8–12 bricks/m²), almost as if it were a wall with two separate leaves, each made from solid bricks (Fig. 8). The floors are made with wooden beams. Three tests were carried out on this building: two compression and one shear-compression test. All tests were done on the external walls on the ground floor.

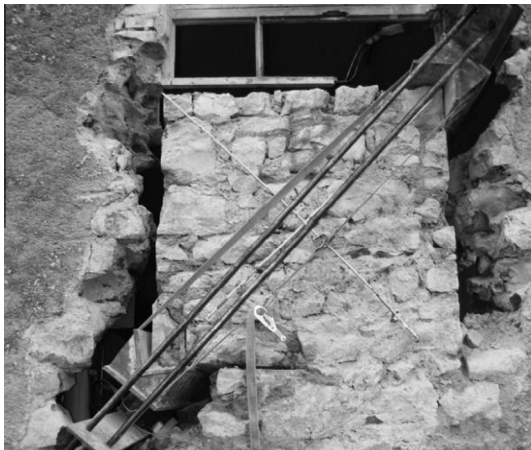
Fig. 9. Un-reinforced panel tested at Colle Umberto.

- 1) For the Colle Umberto building: (a) 5 diagonal compression tests: 2 on unreinforced panels (CD-02-U-OR, CD-06-U-OR), 1 on a panel with preventive reinforcement (CD-07-U-IP) and 2 on repaired panels (CD-08-U-IR, CD-10-U-IR) (Figs. 9 and 10) and (b) 5 shear compression tests: 2 on unreinforced panels (TC-16-U-OR, TC-17-U-OR), 2 on panels with preventive reinforcement (TC-19-U-IP, TC-20-U-IP), 1 on a repaired panel (TC-21-U-IR);

The cracks produced in the unreinforced panels were exclusively in the mortar joints and involved the entire thickness of the wall panel along the compressed diagonal. A similar shear strength (0.020 MPa) was obtained also for the unreinforced panel made with solid bricks at the San Felice building.

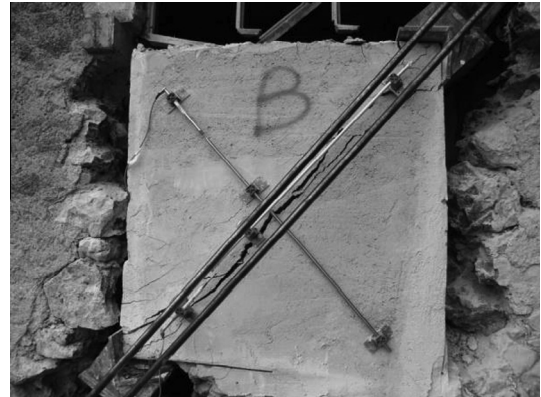
Fig. 10. Crack pattern of a reinforced panel tested at Colle Umberto.

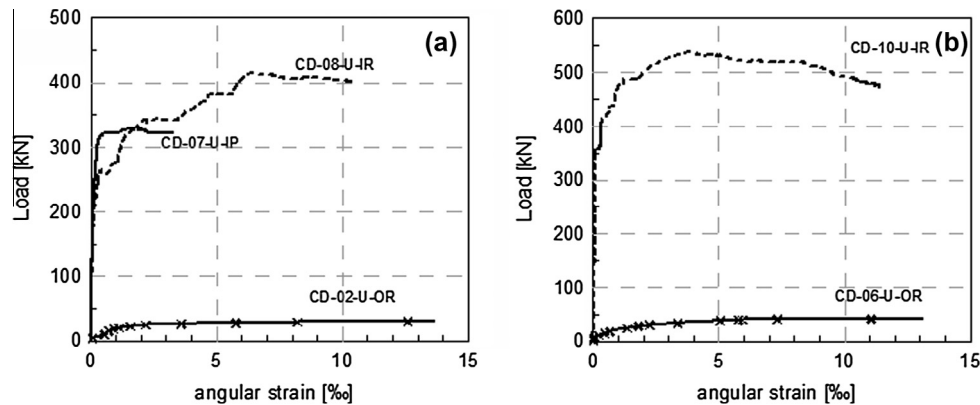
**Fig. 11.** Curves of the shear stress–angular strain response for stone masonry panels, (a) 20th-century masonry and (b) 19th-century masonry (Diagonal compression test method, Colle Umberto).

As regards the panels reinforced in advance or as a technique for repairing pre-damaged masonry, the results showed a substantial effectiveness of the technique tested. The results obtained for Colle Umberto panels (20th-century masonry wall panels) were of particular significance. In this case a shear strength of 0.162 MPa was measured for the panel with preventive reinforcement and 0.209 MPa for the repaired panel, compared to a shear strength of 0.018 MPa in the same panel unreinforced, an increase varying between the 800% and 1060% (Fig. 11).

The elastic phases of the curves of the reinforced panels are characterized by a steeper slope as those obtained in the case of the unreinforced ones, regardless to the type of the stonework masonry. In-plane stiffness (shear modulus, G) increased significantly due to reinforcement (from an average value of 32 to 2622 MPa respectively for unreinforced and reinforced panels in Colle Umberto and from 83 to 765 MPa in L'Aquila). Moreover, we remark an important deformation capability of the unreinforced walls, emphasized by the presence of a relevant post-elastic plateau. The reinforced panels exhibited a smaller deformation capacity compared to unreinforced ones. However this is usual for reinforced concrete/mortar jacketing: if compare this behavior with the one of steel mesh reinforced concrete jacketing we note an important increase in the deformation capacity [15].

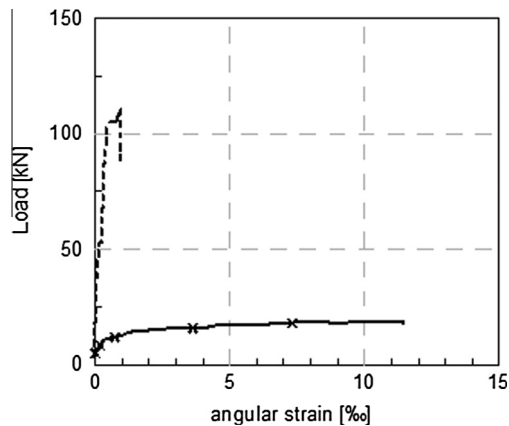
**Fig. 12.** Curves of the shear stress–angular strain response for brick masonry panels (Diagonal compression test method).

The two diagonal compression tests (one on an unreinforced panel (CD-09-S-OR) and one on a panel with preventive reinforcement (CD-11-S-IP) at the brick building in San Felice sul Panaro have essentially confirmed the results obtained on the stone panels, although the effectiveness of the reinforcement was less significant. In this case, there was an increase in shear strength from 0.020 MPa to 0.086 MPa for the reinforced panel (Table 3, Fig. 12). Due to the limited number of headers in the brickwork, the two leaves tend to separate and deform differently during the shear test.

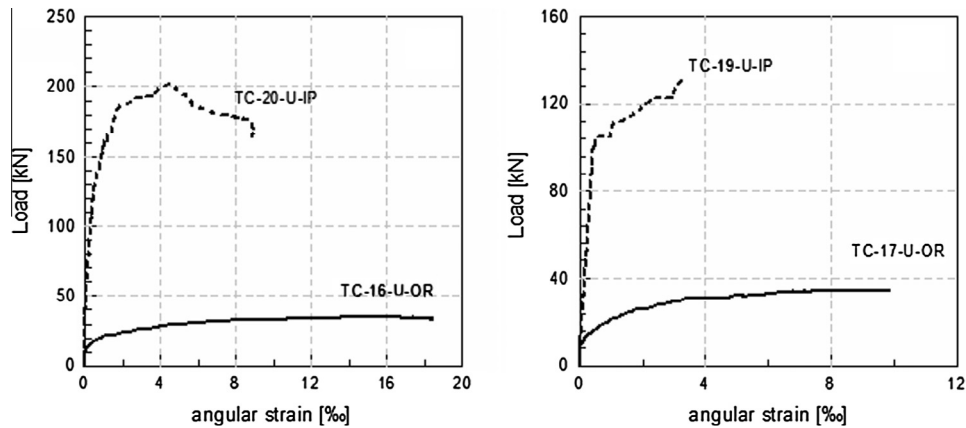
Fig. 13. Curves of the shear stress–angular strain response for stone masonry panels (shear compression test method, Colle Umberto).

For the reinforced Colle Umberto 20th-century masonry panel (with an original thickness of 480 mm), a shear strength increase of 638% was measured, going from 0.032 MPa (unreinforced) to 0.236 MPa (reinforced), while the shear strength of the panel repaired reached 0.173 MPa. Fig. 13 shows a comparison between the graphs of the maximum shear loads of the tests on unreinforced, reinforced and repaired stone panels.

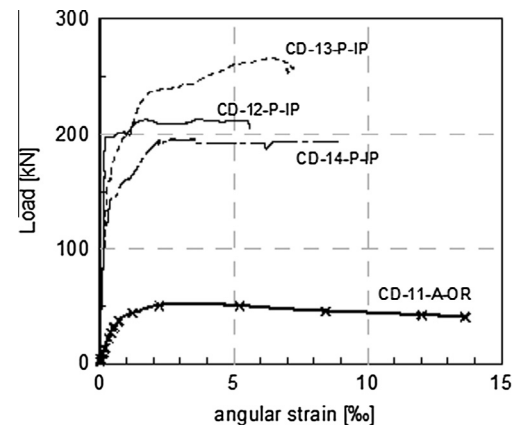
Fig. 15. Curves of the shear stress–angular strain response for stone masonry panels (Diagonal compression test method, L'Aquila).

For panels retrofitted in L'Aquila, the strengthening constrained the development of the cracks, and failure was confined by the GFRP jacketing. The average panel lateral strength increased to 0.0963 MPa (average maximum load 229.7 kN), i.e. the GFRP enhanced the lateral resistance by a factor of approximately 4.33 compared to the control panel (Fig. 15). The ultimate limit state was clearly a shear failure that was initiated by tensile rupture in grid fiber reached when the masonry cracked in tension.

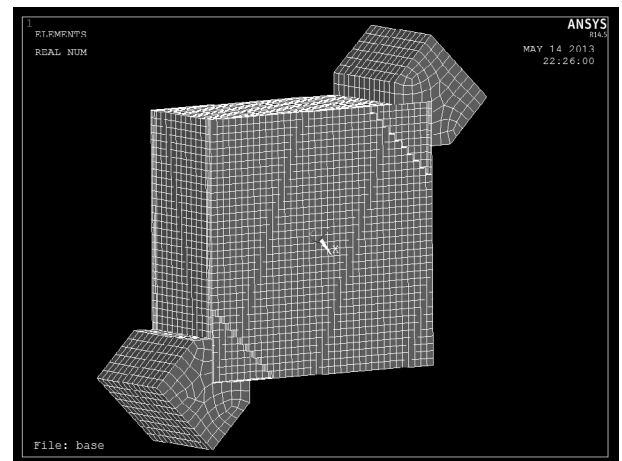
Fig. 16. Model and FE mesh adopted in the numerical simulations.

In view of this, reinforced panels are described by means of a three-dimensional finite element model, in which masonry and mortar jackets are modeled separately (the interfaces being merged with joints). The internal reinforcement (GFRP mesh) was modeled using three dimensional spar elements with plasticity embedded within the solid mesh. This option was favored over the alternative smeared stiffness capability as it allowed the reinforcement to be precisely located whilst maintaining a relatively coarse mesh for the surrounding mortar medium. The inherent assumption is that there is full displacement compatibility between the reinforcement and the mortar jacketing with no occurrence of bond slippage.

Non-linear constitutive laws are adopted for both masonry and mortar jacketing: values of the physical properties of both materials have been established on statistical analysis of experimental data obtained from characterization tests [27,28]. They have been implemented in a general purpose commercial code (ANSYS). Eight-noded hexahedron elements have been adopted. The average size of the hexahedron elements was chosen so as to have ten and four elements across the panel and mortar jacketing thickness respectively: this allows the more critical details to be captured. The complete finite element model (FEM) is shown in Fig. 16.

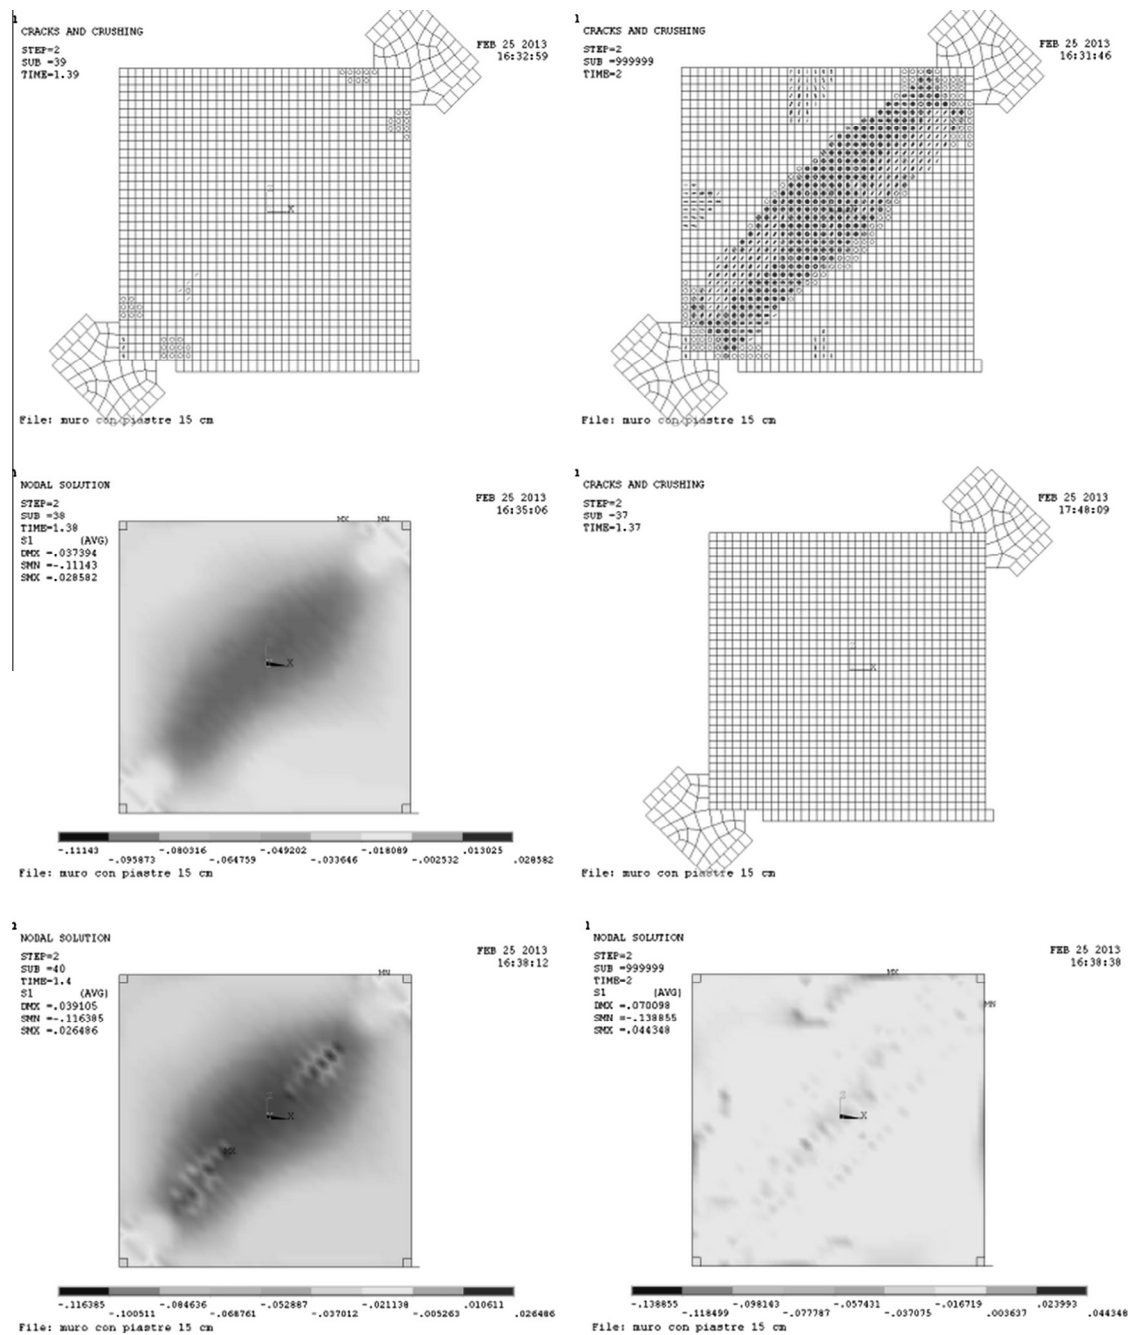
Fig. 17. Tensional results vs crushing and cracking path obtained in the non-linear analysis due to increasing shear load.

The analyses carried out on the non-linear 3D F.E. model have been used to evaluate the shear strength capacity of the tested specimens (Fig. 17).
